Re: Papa Johns
ADA Compliance Evaluation

As requested, I visited the above-referenced property to conduct visual observations in order to provide this ADA compliance evaluation of the KAIS ABID, d/b/a PAPA JOHN'S, KAM FOUR, INC, d/b/a PAPA JOHN'S, PARKER EAST 24th APARTMENTS, LLC and PARKER COMMERCIAL 24th ASSOCIATES and 305 EAST 24TH OWNERS CORP located at 432 Second Ave. New York, New York.

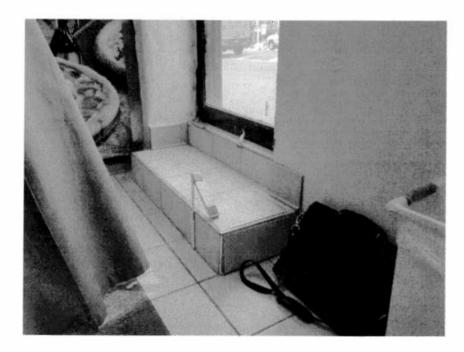
In order to enter the space through the entrance along the sidewalk of 2 Av., a person must descend two (2) steps of unequal riser height (6" and 7") and unequal tread depth.

Picture 1: Store entrance, 6" and 7" stairs on entrance.

- 1. Entrance steps and doorway: To address this condition, a permanent small ramp can be constructed from the sidewalk level up to the main floor level; the ramp would require appropriate slope, railings, and signage as required by 28 C.F.R. 36 to provide an accessible and properly designated entrance. In the alternative, a wheelchair lift may be used. In the alternative, an ADA compliant portable ramp with a non-slip surface may be used in conjunction with ADA accessible signage and buzzer to comply with 28 C.F.R. Part § 36.304 (e). A cost estimate of providing an ADA compliant wheelchair lift is approximately \$10,000.

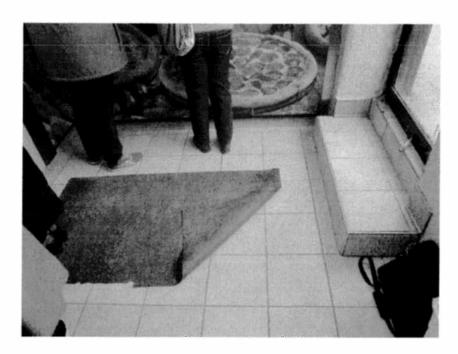
Picture 2: Unsecured entry mat

- 5. Secured Mats: The existing non ADA compliant mats in the store layout can be secured to be in compliance with 28 C.F.R. Part 36 and 2010 Standard, Section 302.2.

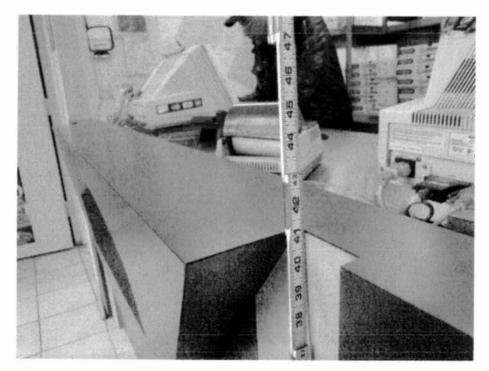
Picture 4: Inaccessible service and transaction counter 41" (h)

- 2. Transaction counter: The existing non ADA compliant transaction counter can be modified to comply with 28 C.F.R. Part 36, Section 7.2(1), which requires that a portion of the main counter (measuring a minimum of 36 inches in length) be provided, with a maximum height of 36 inches above the finished floor. The cash register display screens should be lowered with the transaction counter. A cost estimate of lowering the transaction counter is \$2.000.

- 3. Service Counter: The existing non ADA compliant service counter can be modified to comply with 2010 ADAAG, Section 902.3 which requires a portion of the main counter (measuring a minimum of 36" in length) be provided with a maximum height of 36" above the finished floor. The cost estimate of lowering the service counter is the same as the cost for lowering the transaction counter.

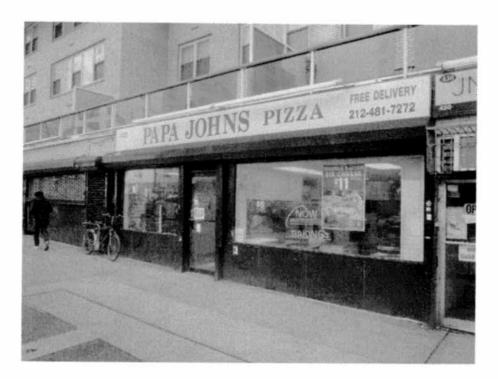
Picture 5: Exterior
